MAUI ELECTRIC COMPANY

Investigation of 2006 Maui Island -Wide Power Outage PUC Docket Number 2006-0431

PROJECT NUMBER:
111699

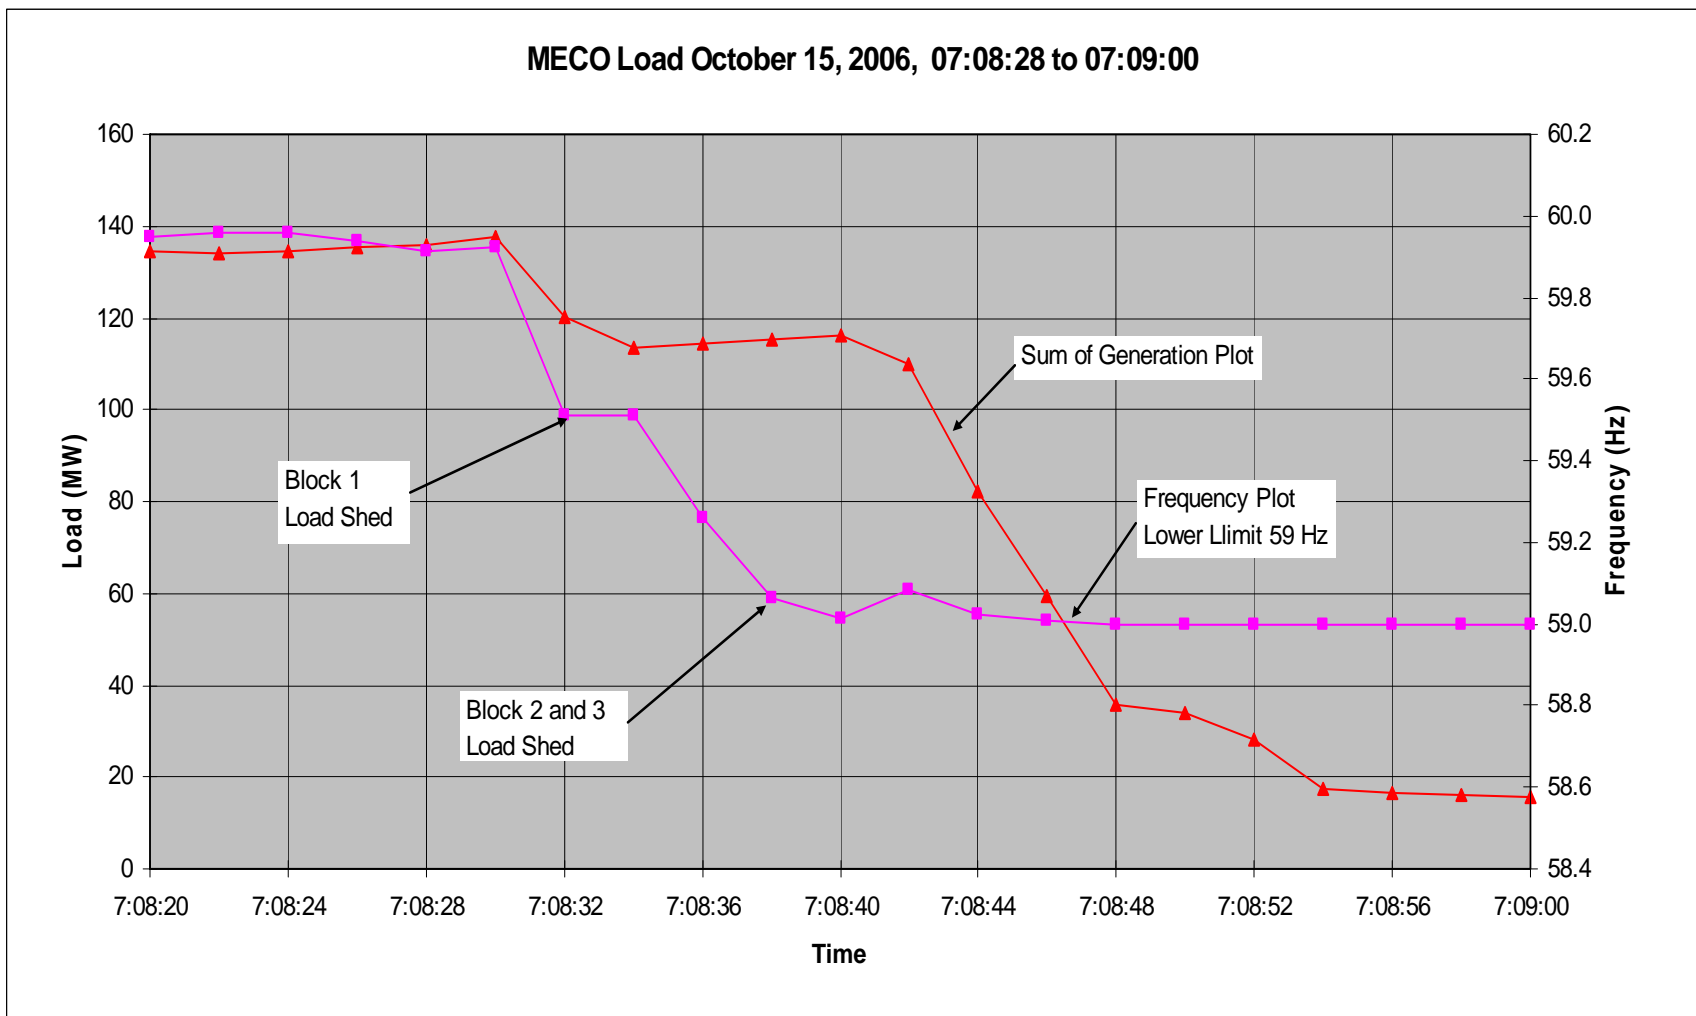
Figure 1: Load versus Frequency Timeline - October 15th, 2006, 07:08:20 to 07:09:00

From Figures 1 and 2, it appears that the generator trips of M14 and M16 caused the frequency to quickly decay below the 58.7 Hz trigger-point of the UFLS block 1. UFLS block 1 operated along with a ramp-up in power output from the other generators; the frequency recovered to above 59.5 Hz and then began to decay again as the power output from M14 and M16 finally dropped to zero at 07:08:38.

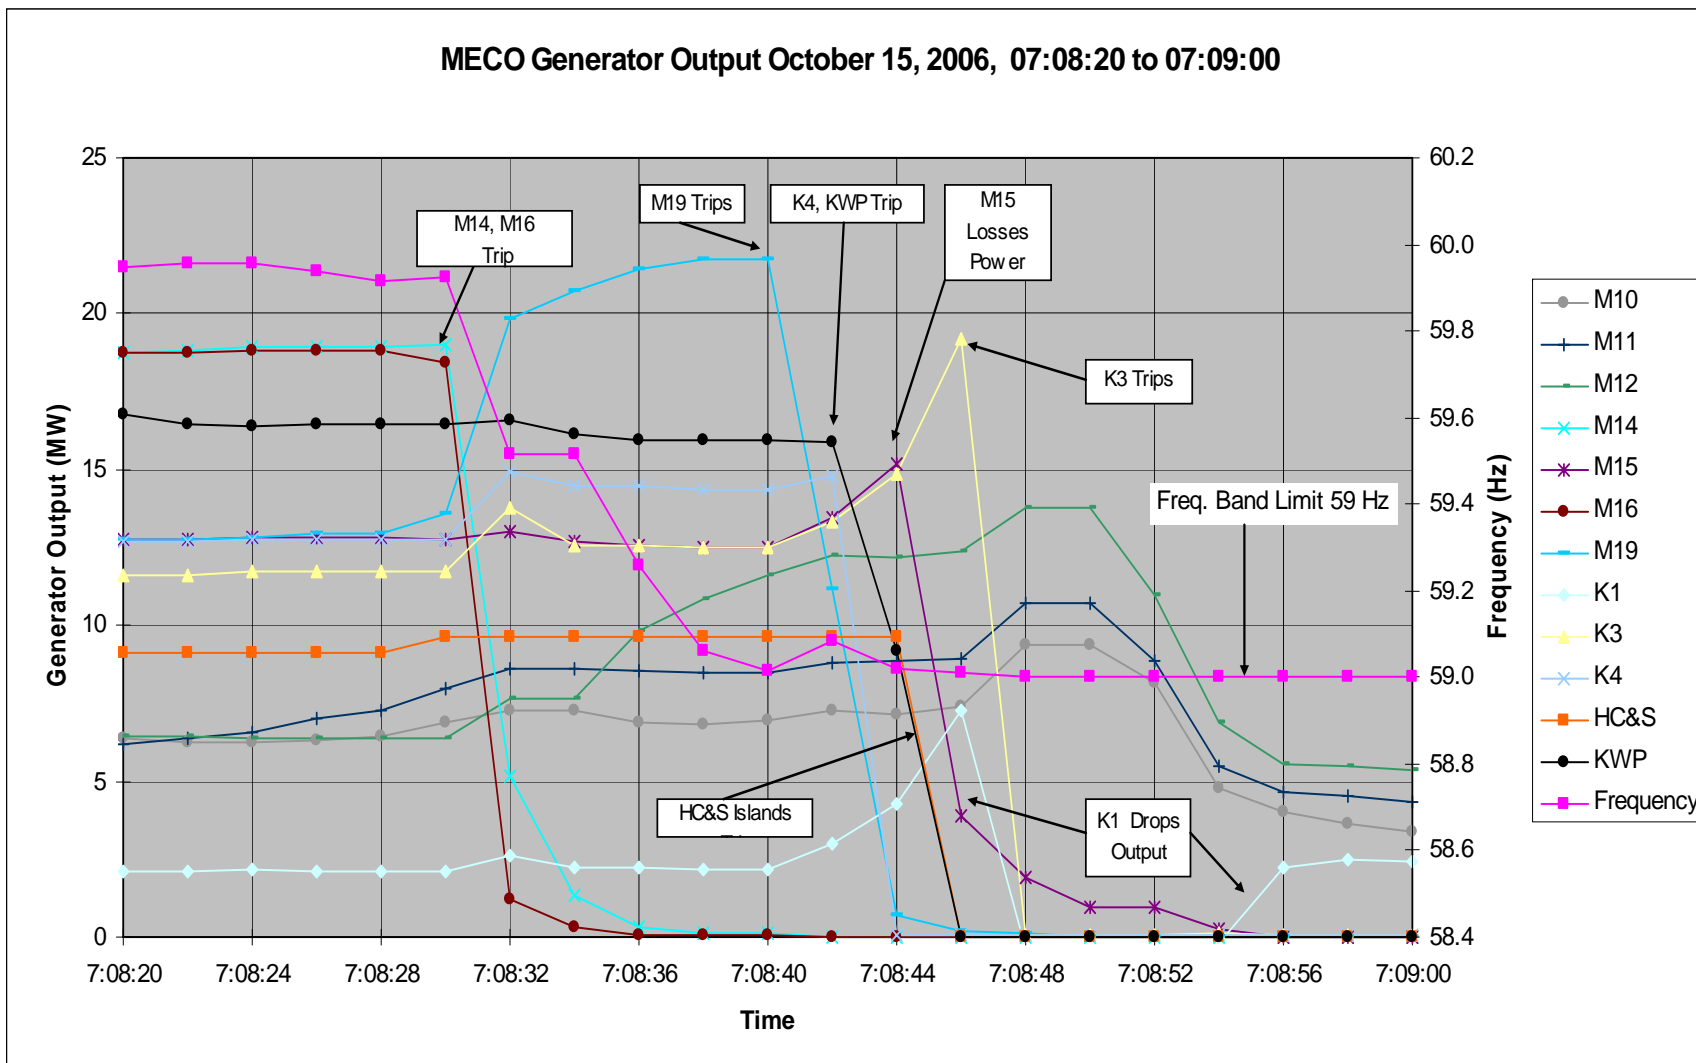
Figure 2: Individual Generator Output Timeline - October 15, 2006, 07:08:20 to 07:09:00

Power plants can be tripped in two ways. First, a trip to “shutdown” where the power reduces over a short time and the generator circuit breaker to the system remains closed until tripped by the operator (power output reduces over more than the 2 second scan interval). Second, a trip by a protective device that opens the generator circuit breaker to the system immediately, thus shutting off the power output (power output reduces to zero within the 2 second scan interval). Both of these type events can be seen in Figure 2.
