March 28, 2007

HAWAII ELECTRIC LIGHT COMPANY

Investigation of 2006 Hawaii Island Power Outage PUC Docket Number 2006-0431

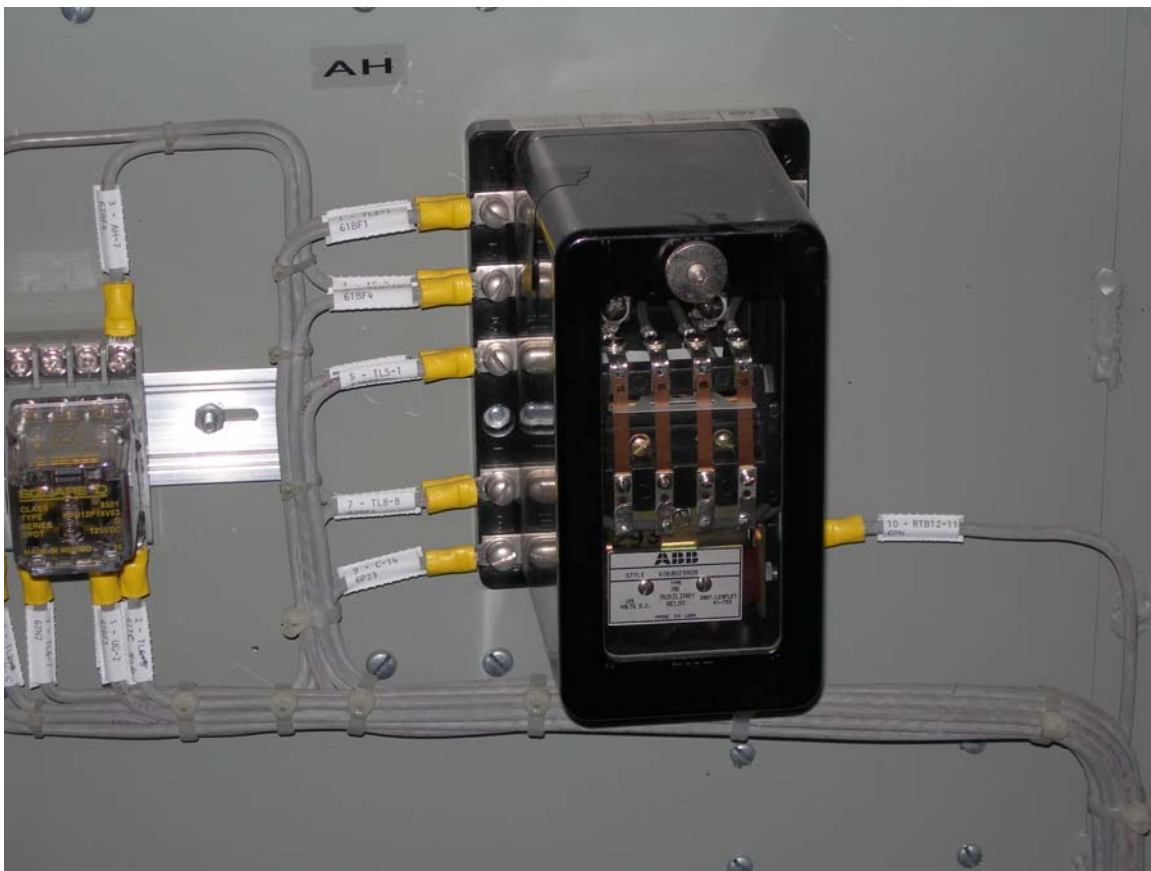
Figure 5: Transmission line AR relay.

Inspection and assessment by the T&D staff during and subsequent to the restoration indicate that relays on 12 of the 69 kV lines that tripped recorded a direct trip (DT), with no other fault sensing relay initiating the trip. After some investigation, it appears that an auxiliary relay contact momentarily closed, attributed to the earthquake shaking, to direct trip the transmission circuits. These relays are an ABB Style AR auxiliary relay. These auxiliary relays are commonly used in the electric utility industry to provide additional contacts from one relay to other protection and control schemes. The HELCO AR relays are typically mounted on the back of the relay panel, as shown in Figure 5, or on swing panels located on the rear of the main relay and control panel.

These auxiliary relays do not result in a lockout condition so the lines were able to be remotely closed through the SCADA by the System Operator by 0800 hours. While these relays mis-operated, the inadvertent operation resulted in disconnecting load on the west side of Hawaii which helped to offset the loss of the HEP combined cycle units and Hill 6, as indicated in section 3.2.3 above. Relays on transmission lines 7300, 7700, 8600 and 6500 indicated that they had tripped due to phase-to-phase faults, most likely due to phase wire contacts due to the earthquake shaking. These trips are evaluated to be correct operations.

1. The main underlying cause of the partial system outage was the earthquake inducing the operation of relays during the seismic shaking of transmission line ABB Style AR auxiliary relays; and Qualitrol Fault Pressure sensors with electro-magnetic target relays. This led to an outage of the transmission system from north of Kealia in South Kona to Pepeekeo on the Hamakua coast. The earthquake also initiated the trips of HEP on vibration. The loss of load on the east side of the island from the transmission system separation initially resulted in over frequency on the remaining portion of the system, which then went into under frequency and load shed when Puna Steam, Hill 6 and Hill 5 went off-line. Recommendations are presented to assess and remedy these issues.

1. Evaluate the transmission relaying equipment, mounting methods, and operational schemes related to the employment of ABB, Style AR auxiliary relays to provide relay protection schemes that are less likely to miss-operate during seismic events.
2. Investigate and evaluate the likely miss-operation of the Qualitrol Fault Pressure sensors with magnetic target relays protective equipment installed on HELCO transformers. Determine appropriate sensor/relay replacements or scheme changes that reduce the likelihood of the tripping of substation and generator step-up transformers due to miss-operation during seismic events.

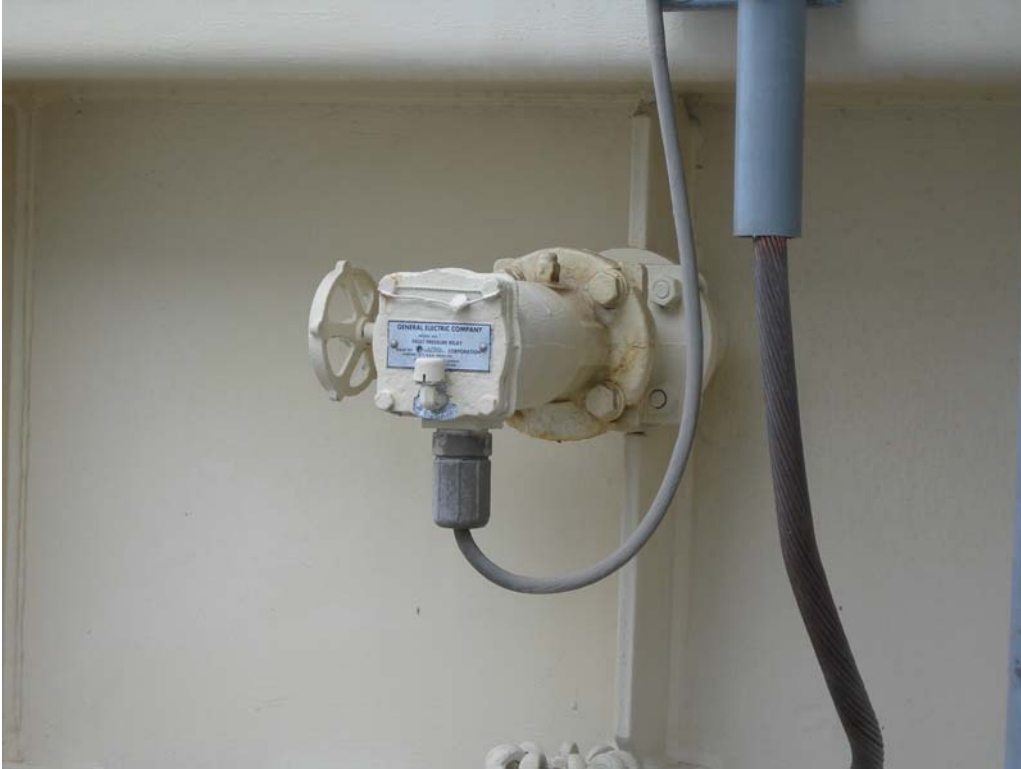
Figure 6: Transformer Fault Pressure Sensor Qualitrol.

HELCO T&D staff noted that 8 transformers had the 86T operate and lock out, had similar sensors and target relays. These sensors are a Qualitrol Fault Pressure sensor as shown in Figure 6 with a magnetic target relay as shown in Figure 7.

The transformers were visually inspected and no indication of an overpressure condition was noted, such as rupture of a pressure release disk or setting of the pressure release flag. Once the coincidence on equipment was noted, HELCO staff test closed on the Keahole diesel generator transformer while monitoring the existing metering and protective relaying. Since Hawaii is remote from transformer repair facilities, they determined that an internal fault would most likely require replacement of the transformer rather than shipping the unit to a repair facility. Thus, there was little risk that re-energizing a faulted transformer, and increasing internal damage would extend the outage time if a replacement would be required anyway. When this transformer did not show any sign of a fault, they then continued to reset the other substation transformer 86T lockout relays and re-energize the transformer while monitoring the metering and relaying for signs of an internal fault. At this time, it has not been determined whether the miss-operation was due to the sensor or the target relay. It is possible that the sensor construction allowed the seismic acceleration of the oil to trigger the device or that the target relay closed its contact due to seismic shaking.
