March 28, 2007

HAWAII ELECTRIC LIGHT COMPANY

Investigation of 2006 Hawaii Island Power Outage PUC Docket Number 2006-0431

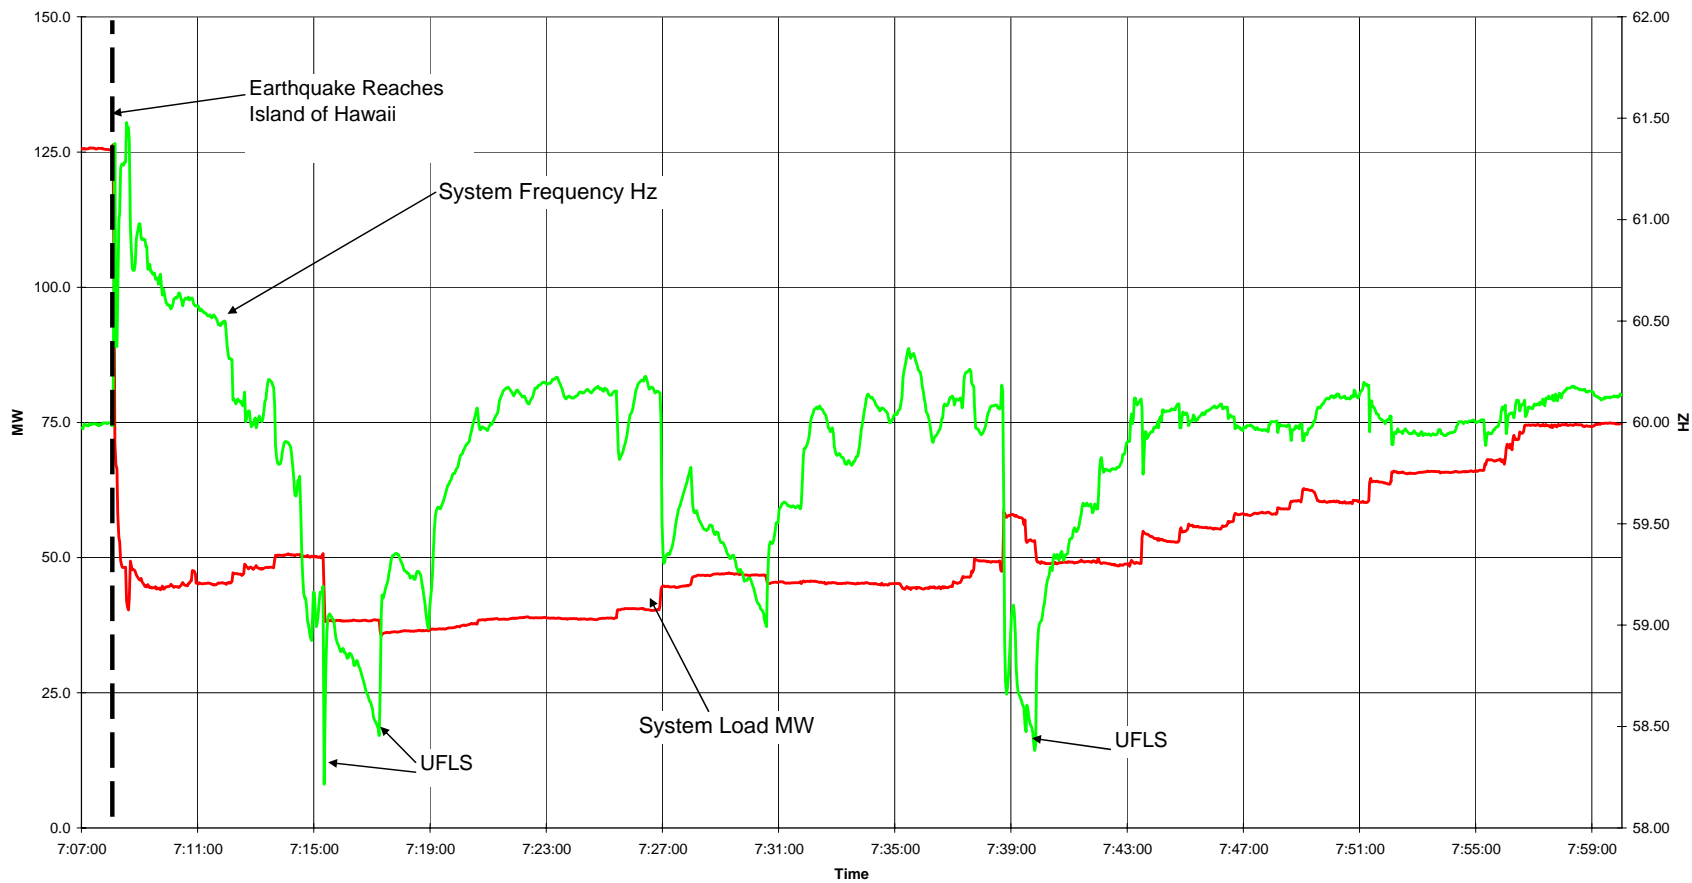
This report was reviewed against information from the EMS, supervisory control and data acquisition (SCADA) reports, and relay event reports. This sequence of events coincides with the information displayed in the following figures. Figure 1 shows the system generation and frequency on the HELCO system from the time of the earthquake until 0800 hours when the frequency stabilized. Figures 2 shows the megawatt output of the separate generating units and the system frequency, with the timing of significant events, from 07:07:00 to 07:21:00 to provide an expanded view of the generator operation events.

Figure 1: System Load versus Frequency Timeline October 15th, 2006

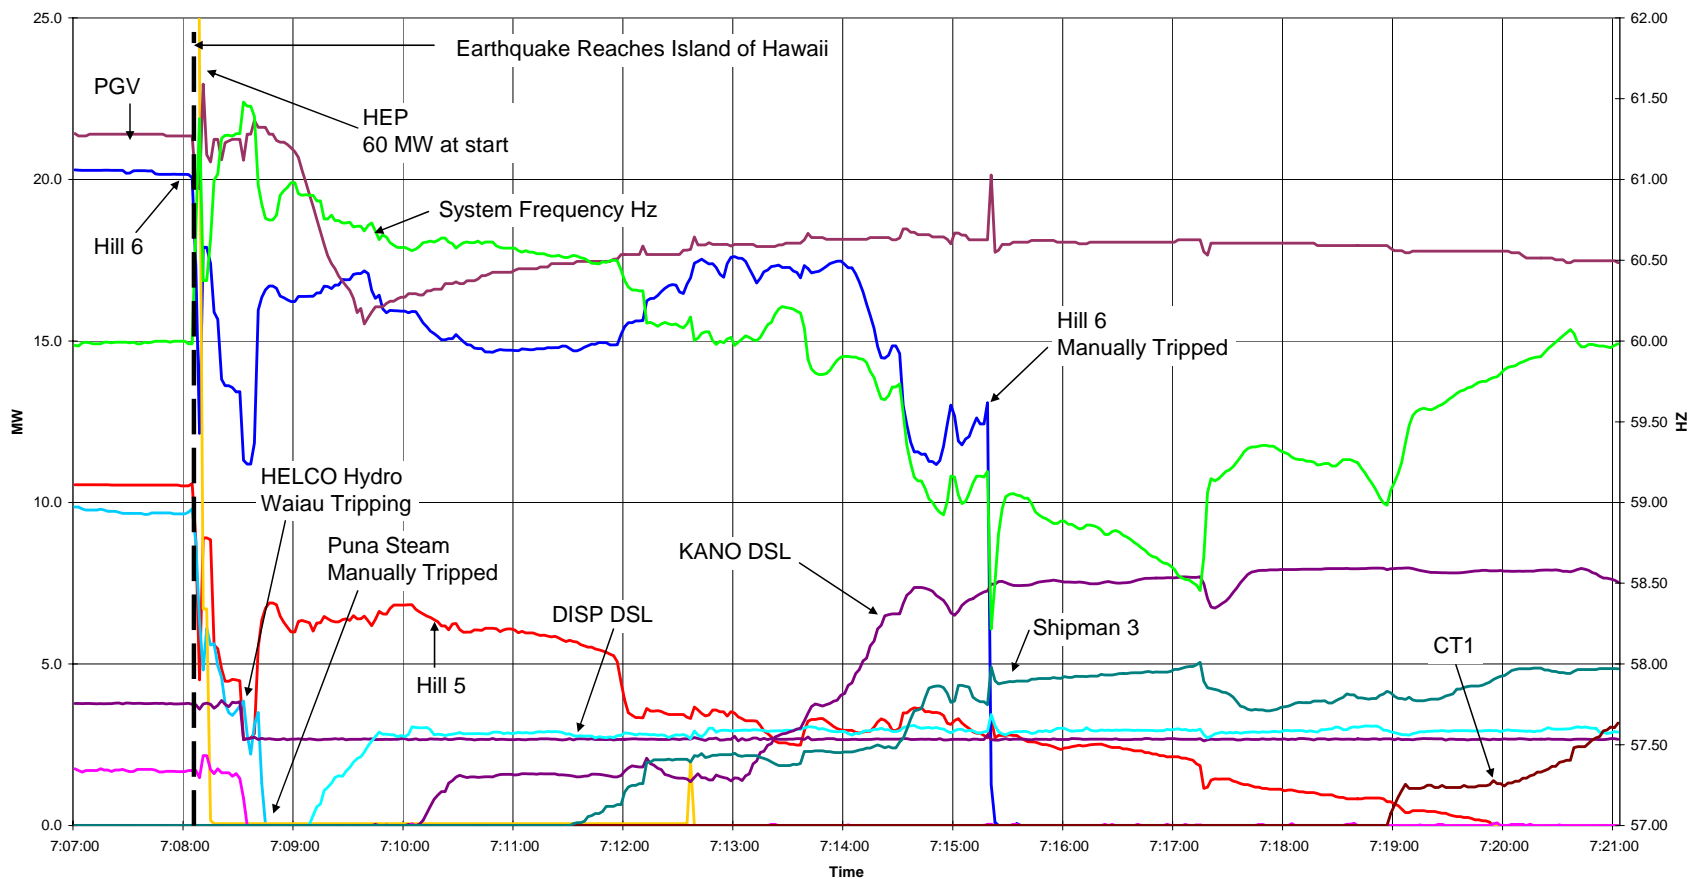
Figure 2: Individual Generator Output Timeline - October 15, 2006, 07:07:00 to 07:21:00

Trips of the transmission circuits blacked out the system from Pepeekeo around the north and down the west side of the island to Kealia. The initial loss of load resulted in over frequency with generation exceeding load on the east side of Hawaii. The Hill 5, Hill 6, PGV and Puna units reduced output to match generation with load as indicated in Figure 2. Waiau and Wailuku hydros tripped off-line.

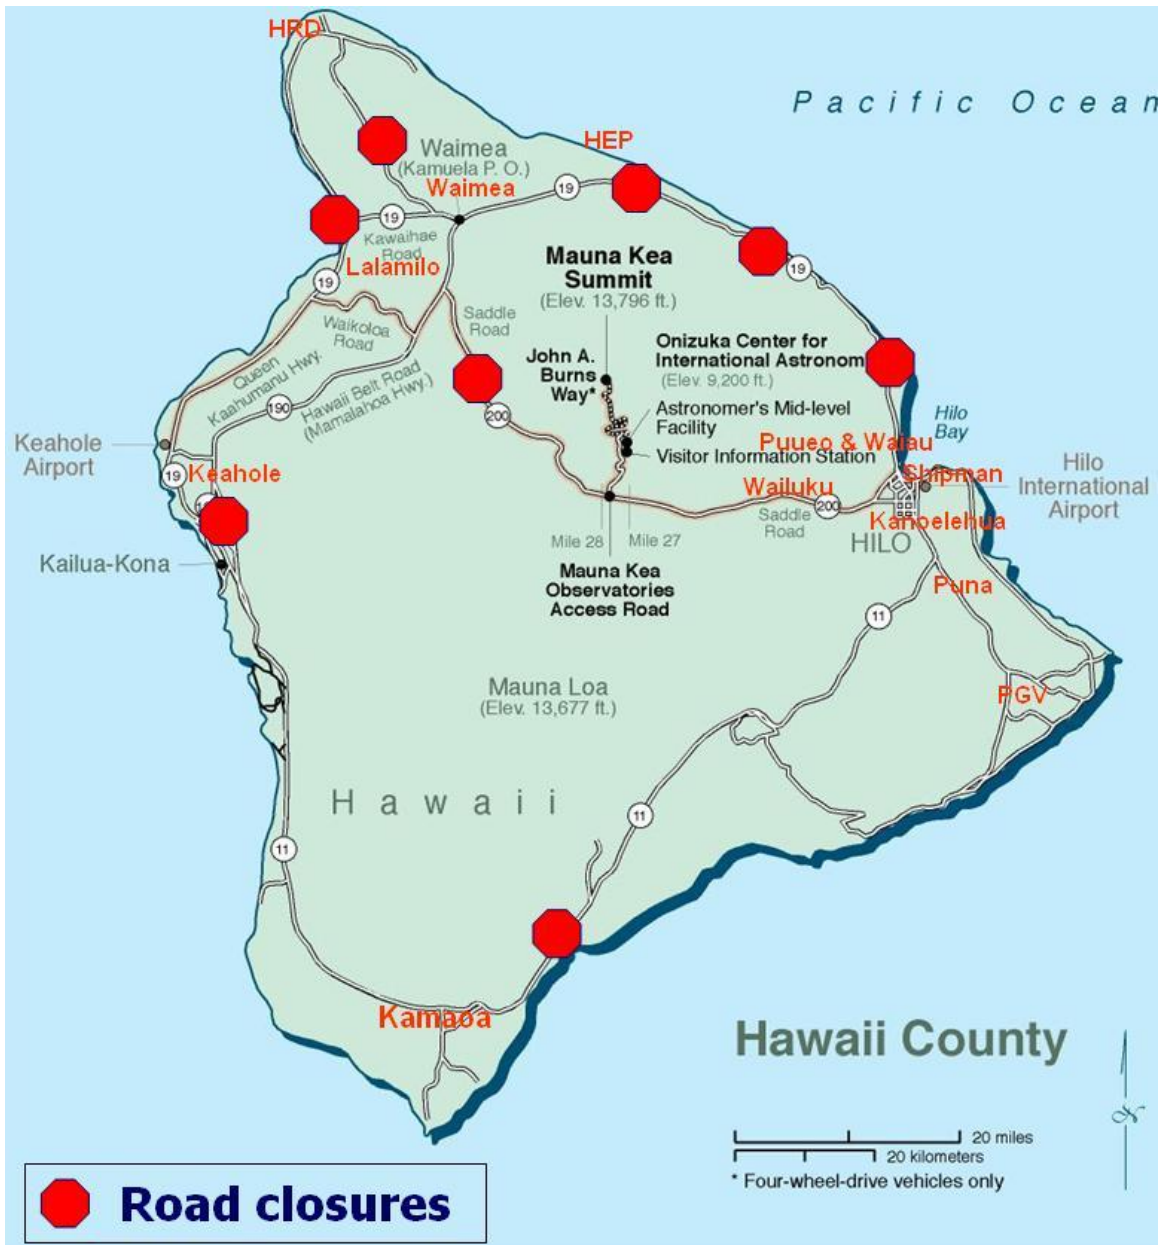
Restoration activities were hampered by road closures as shown in Figure 3.

Figure 3: Initial Hawaii Road Closures Due to the Earthquake

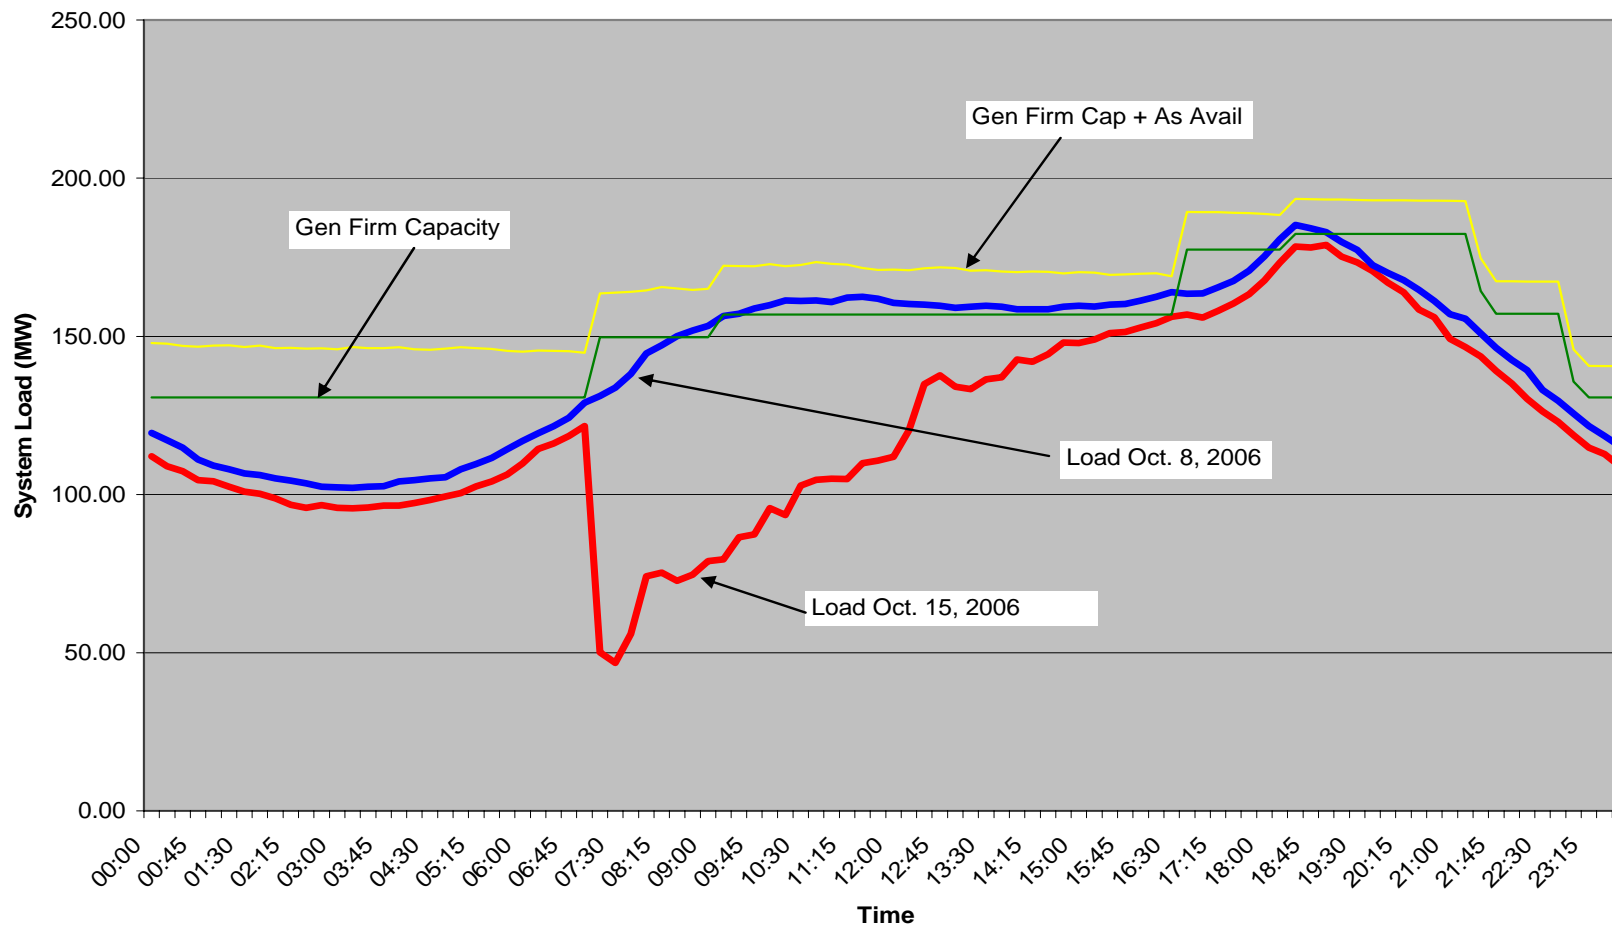
Figure 4 shows the load curve for October 15th in comparison to load on Sunday October 8th. The curve profiles for October 8 and 15 are similar prior to 0707 hrs and after 1800 hrs. Firm capacity and firm capacity with as-available generation are also shown on the graph, to illustrate the reserve margin that is typically available.

Figure 4: October 15, 2006 Generation Compared to Previous Sunday Load Curve
